The Status quo and Problem of User Well-Being Related to Standard Design School Buildings: A Case Study of Primary School Buildings, Mueang District and Area, Nakhon Ratchasima Province

Pattamaporn Rattanapradab^{1*} and Yingsawad Chaiyakul²

^{1,2} Faculty of Architecture, Khon Kaen University, Khon Kaen, Thailand

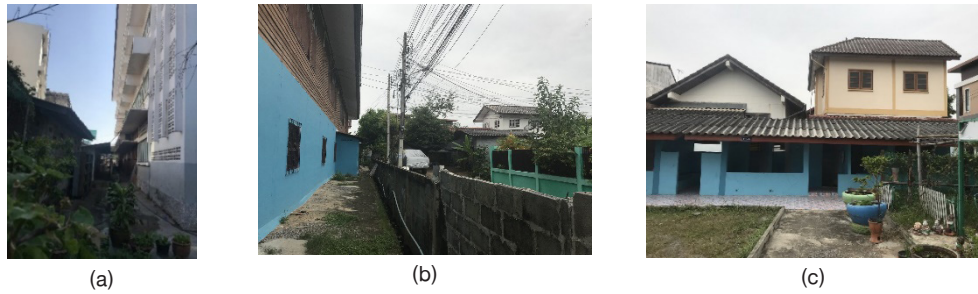
Figure 4 Adjacent buildings in and around the urban Amphoe Mueang area: (a) nearby 3-4 storey buildings, (b) a thoroughfare next to the building and (c) nearby 1-2 storey buildings.

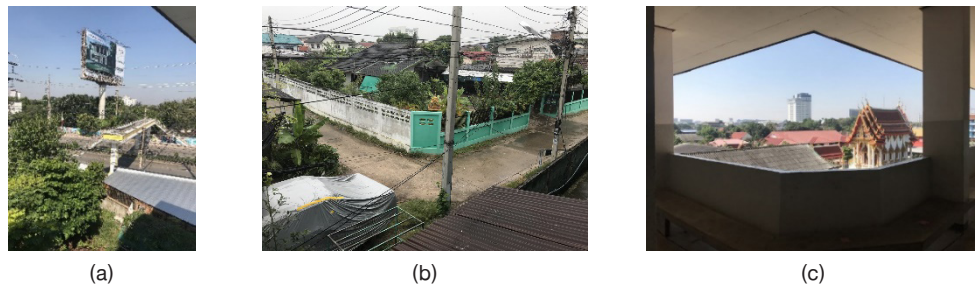
Figure 5 Views from school buildings in urban areas: (a) view next to the main thoroughfare, (b) view next to a communal thoroughfare and (c) general view from school building.

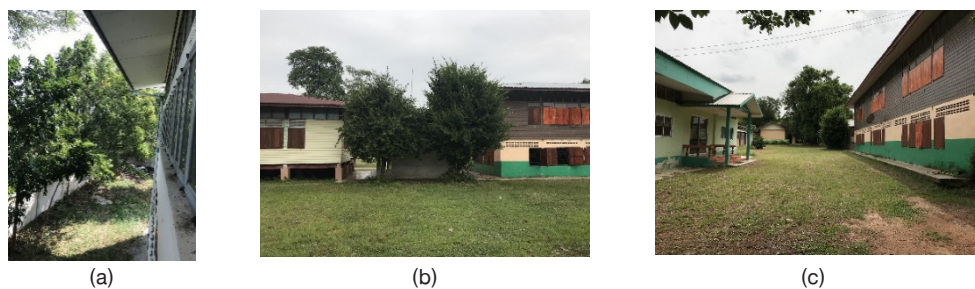
Figure 6 Adjacent buildings in the suburban area: (a) nearby agricultural areas and a railway line, (b) nearby 1-2 storey buildings and (c) open space next to the building.

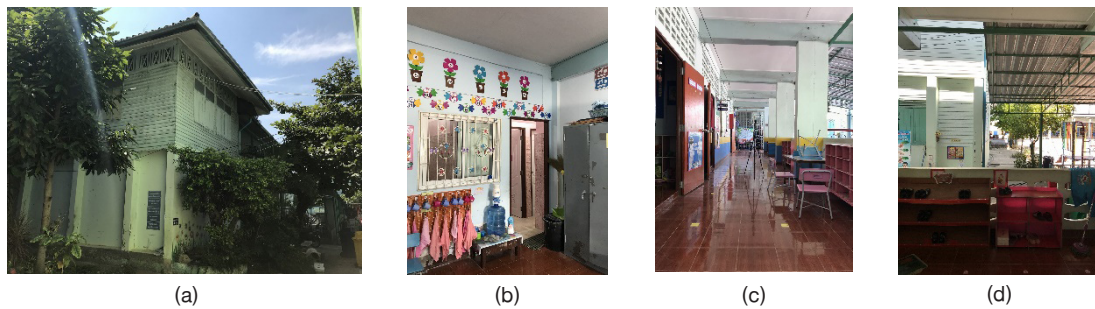
The 2nd floor classrooms of four school buildings, Type A and B, were no longer in use due to the decreasing number of students. These spaces have been reassigned as storage and other uses. For example, A1, A2 (Figure 9) and B2 (Figure 10) only use the 1st floor for kindergarten and primary level classrooms. Other areas are used as offices, kitchen and food preparation, and washing area. Moreover, furniture for storage has also been integrated in classrooms. In addition, there are some building extensions like toilets and wash basins in the kindergarten area. Wooden doors and windows were replaced with aluminum and glass panels as well as retiling and new paint as part of renovations of the wooden buildings.

Figure 10 Extensions to Type B building: (a) a new plastered brick wall; (b) bathroom extension connected to kindergarten from the inside; (c) new tiled floor and (d) added roof structure at the front of the school building.

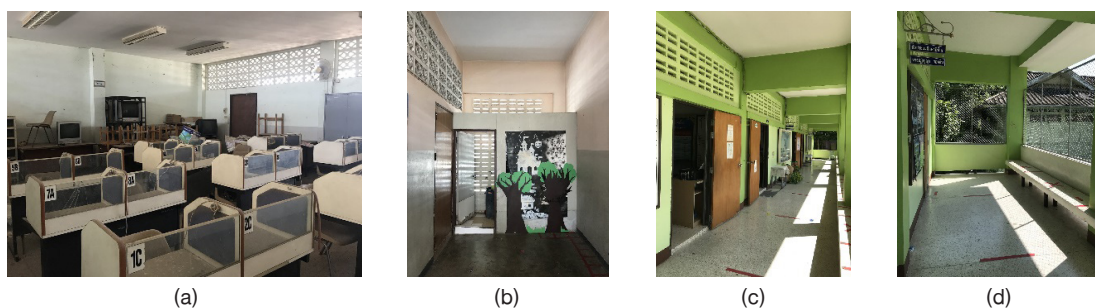
The same reason for space repurposing was observed at four of the 2-4 storey Type C and D buildings. Classrooms have been used as storage, infirmary, offices, and meeting rooms. The C1 building (Figure 11) and D1 building (Figure 12) use the 1st floor area without walls for common gathering space and as a canteen. There are toilet extensions in the space underneath the stairs and at the end of a walkway. In addition, a kitchen and a washing area have been added to accommodate the canteen in building D1.

Figure 12 Extensions to Type D building: (a) a classroom used as a storage; (b) additional toilet was installed at the end of a corridor; (c) a classroom used as an office and (d) fall prevention wall was added to the top floor of the building.
