# The Practical Renovation of a Privately-Owned Wooden House: Case of Khun Prasit's House, Ang Thong Province, Thailand

Teranetr Tienthavorn

Faculty of Architecture, Chulalongkorn University, Bangkok, Thailand

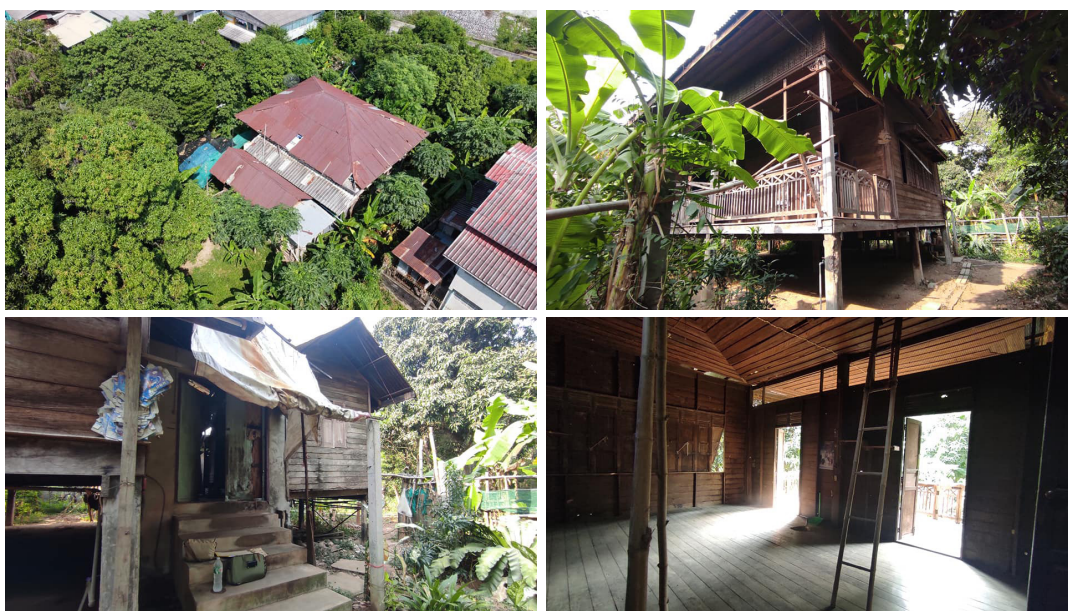
Khun Prasit's house is situated near the Chao Phraya River in an area susceptible to flooding. Flood deposits have elevated the ground level such that the height of the first floor was only 1 meter above the ground. By observation, the wooden columns and roof structures were severely damaged due to moisture and age. The floors and walls had partially deteriorated. The house consists of bedrooms, kitchens, and a toilet (Figure 2). It was difficult to identify some of the original architectural features since no pieces of evidence regarding the original design remained. From observations in 2021, the roof was made of galvanized iron corrugated sheets which were imported from a foreign country. However, in the old days, wooden houses with the hipped roof were mostly finished with Thai kite-shaped tiles. The roof structures such as rafters, purlin, and roof beams are believed to have been made of *Dipterocapus alatus* Roxb. ex G.Don Dipterocarpaceae (Yang Na trees). These woods are highly prevalent in tropical settings, especially along the Chao Phraya River in central Thailand. However, the structure is usually made of wood with higher strength such as *Hopea odorata* R.oxb. Dipterocarpaceae, *Shorea obtusa* Wall. Dipterocarpaceae and *Pterocarpus macrocarpus* Kurz Fabaceae (Forest research and development office, 2005)

**Figure 2** Surveying the existing house, prior to renovation  
(Credit: (top left) North Forest Studio, (top right and bottom) researcher)

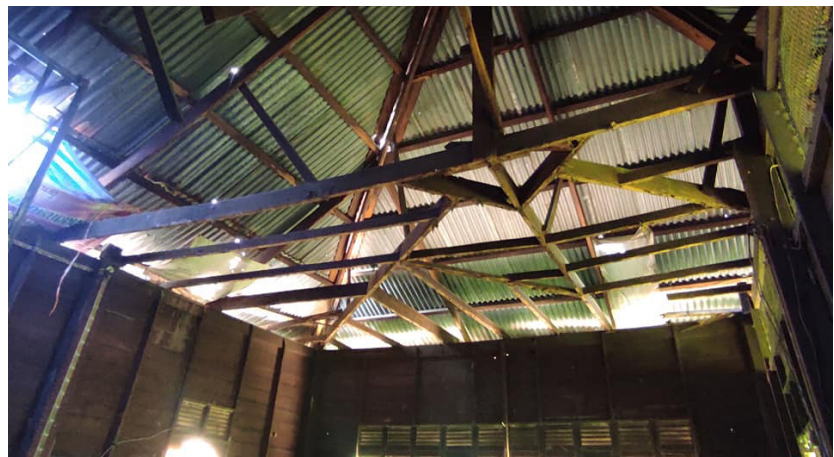
The unique characteristics of the house were the roof style and roof structure. Khun Prasit's wooden house is not vernacular, but an adaptation of western-style architecture. From a historical viewpoint, in that period of modernization of Siam, Western culture had influenced the country in several aspects including architecture. The "colonial-style architecture" featuring a hipped roof was popular in King Rama IV and King Rama V periods (No Na Paknam, 2020). From the architect's assumption, the roof structure represents the western style (C. Nuntapanich, personal communication, December 4, 2021) (Figure 4).

**Figure 4** Unique characteristics of the roof structure (Credit: researcher)

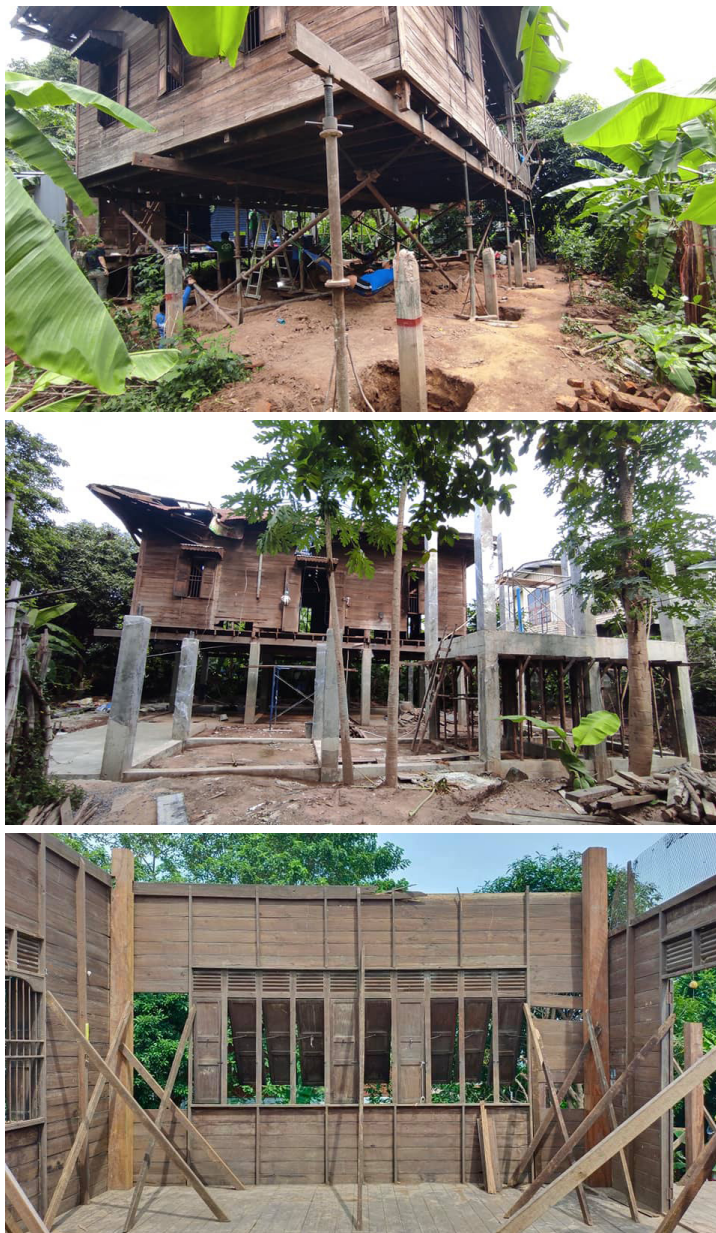
The renovation process began with an agreement between the owner and the architect, followed by a survey of the building, site, and landscape. Interviews were undertaken with local residents to obtain the oral history of the house. The active work started with measuring the existing house. The renovation process was divided into 3 phases; lifting the wooden houses, rebuilding the service zone, and restoring the main wooden house (Figure 5), each of which required different skills and knowledge.

**Figure 5** The three phases of the renovation process; (top) lifting the house, (middle) rebuilding the service zone, and (bottom) wood reconstruction and repair (Credit: researcher)

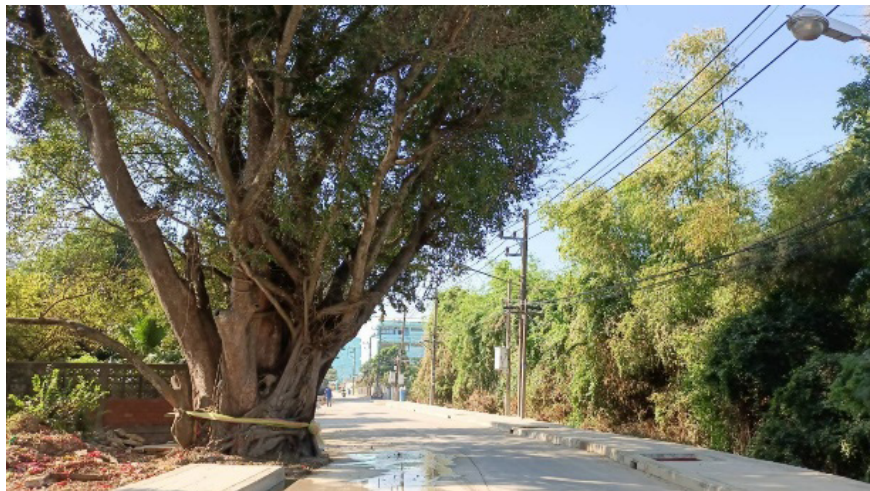
**Figure 6** Nature observations and understandings: *Crudia chrysantha*, (Pierre) K.Schum tree  
(Credit: researcher)

To use wood efficiently requires knowledge and understanding of wood from a natural perspective. The availability of wood is essential to the decision-making, consumption, and production. The architect’s decision on the wood application was based on the characteristics of the original house and its landscape. This area previously was zoned government and penitentiary use before the central town was moved to the other side of the river. Subsequently, the zoning was changed to become a residential area. However, as time passed, wooden houses in the area gradually disappeared. From the interview, the architect found a *Crudia chrysantha*, (Pierre) K.Schum tree (Figure 6), which is approximately 100 years old, and can be related to the boundary of the landscape. This is one of the clues to the setting of the house.

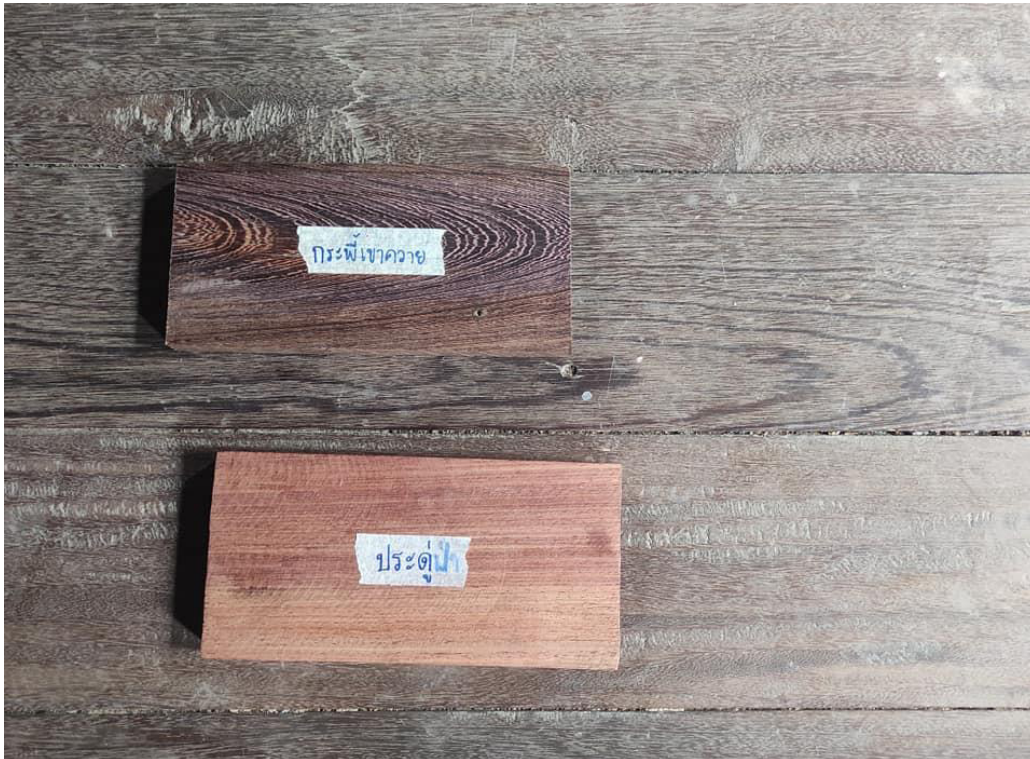
Furthermore, in the process of survey, knowledge about the tree species can increase processing speed. Floor plank observation, for example, is influenced by the grain pattern and color which differs between species. As shown in Figure 7, mostly the wood used for flooring is *Pterocarpus macrocarpus* Kurz, a bright wood identifiable by the bird-feather pattern with reddish-yellow color (a bright wood in the bottom of Figure 7). However, some pieces of wood in the floor plank are not the same species. The dark brown wood with an elaborate bird-feather grain is *Dalbergia cultrata* Graham ex Benth (a dark wood in the top of Figure 7). The original roof structure was constructed using *Dipterocarpus alatus* Roxb. ex G.Don wood, but it was later replaced with a harder wood during renovation.

**Figure 7** Floor plank material survey of the pattern grains in different species of wood  
(Credit: researcher)

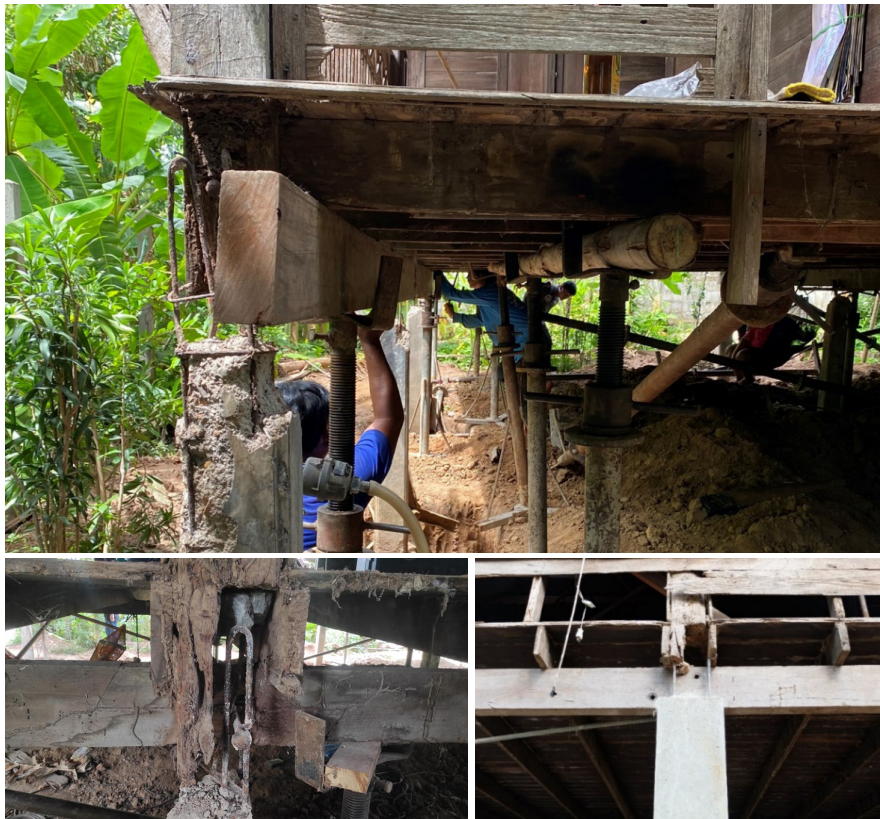
To illustrate, when the builder tried to lift the house, the wooden beam showed signs of cracking thus the process had to stop so that the wooden beam could be changed immediately (Figure 9). It was necessary to expose the joints before lifting the house, which revealed that the wood around the joints was severely damaged due to moisture. The original beam was approximately 2”x6” and the decay was serious at the joint between concrete and wood. The carpenters, as well as the wood suppliers, supported the workers who were elevating the house by immediately making a 3”x8” replacement beam.

**Figure 9** An unplanned situation resulting from the sign of a cracked beam during house lifting (Credit: researcher)

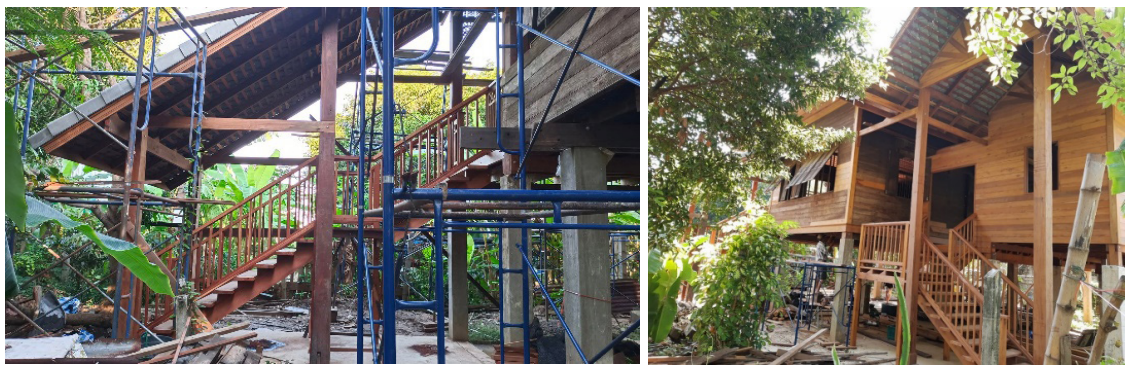
Layout and access were changed from the riverside to the roadside, so the service area can be seen from the new entrance (Figure 10). In terms of structure, the footings, columns, and beams were all removed and replaced with stronger new members. For example, the old 8”x8” columns were changed to 10”x10” columns. The species of wood might be different from the original species, but they were of similar strength. The wooden columns on the upper floor were also removed due to the biological decay of wood. The joist was repaired by splicing the old wood with the new wood (Figure 11).

**Figure 10** After renovation of main house and service area  
(Credit: (left) researcher, (right) North Forest Studio)

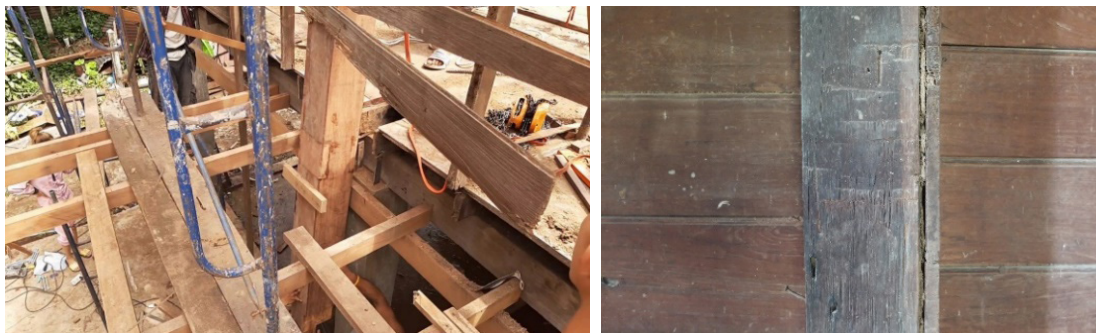
**Figure 11** Different levels in interventions: changing columns and replacing wood in joists  
(Credit: researcher)

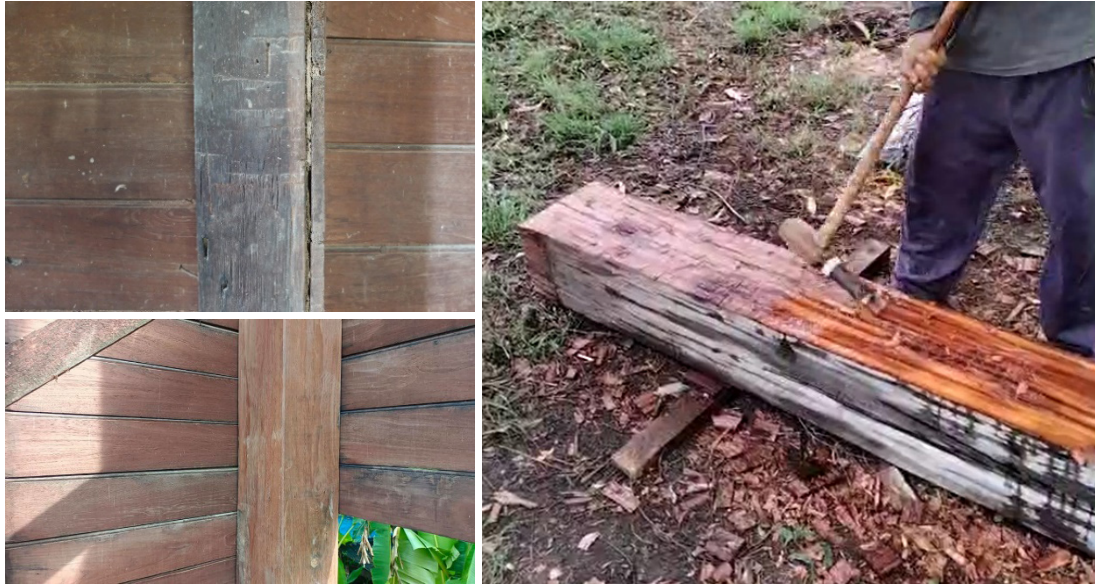
In terms of the column texture, the old columns’ surface was rough because the log was whittled by an adze. The traditional tool was called a “Khwan Yon” (throwing adze) (Figure 12). This project used prefabricated wooden columns sourced from a lumber factory due to the convenience and the availability of resources. This can be considered a loss of the traditional techniques.

**Figure 12** Old and new column texture and an adze  
(Credit: (left) researcher, (right) North Forest Studio)

However, without guidance or standard, the process may miss some details which leads to the loss of cultural significance. For example, the texture of an adze was missing when using the prefabricated columns. Moreover, a concern that came from the direct experiences of the architect was associated with traditional construction techniques, such as traditional joinery. The Dueai-khen joints, which reflect the local craftsmanship, were added to the extension area of the house since the research could not uncover evidence about the original techniques used for this area of the house. This decision-making represents the deeper technical value of the architect.

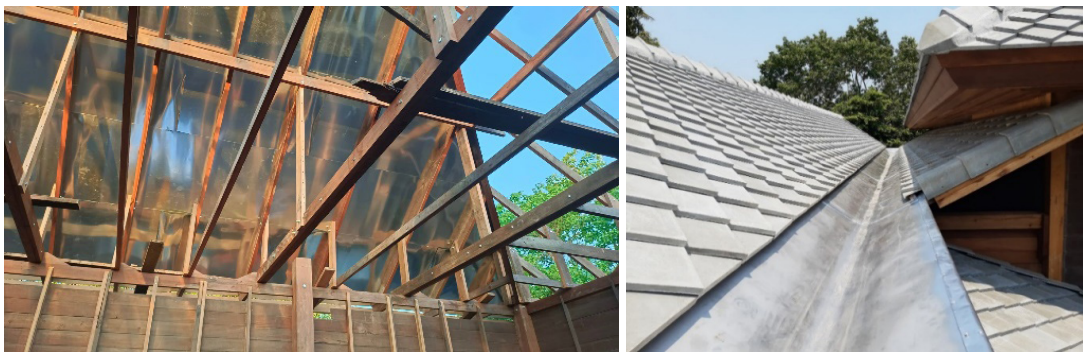
The roof structure was replaced with new members, but the original frame character was retained. The architect used *Hopea ferrea* Dipterocarpaceae for the roof structure renovation. The wood frame members were fastened by bolts. The galvanized iron roof was changed to kite tiles, which considerably increased the structural load of the house (Figure 13). This type of roof material is normally seen in the hip style of the contemporary period. Apart from the load of the material itself, the small size of the tiles resulted in the multiplication of the number of wooden purlins. Consequently, the decayed columns could not carry the load of the new roof, which affected the structural performance. Roof flashing was added to keep the roof sealed and avoid leaks.

**Figure 13** Roof structure and roof tiles (Credit: (left) researcher, (right) North Forest Studio)

New materials and appropriate technologies were introduced into the renovation, including use of roof flashing, to improve the safety and efficiency of the house. Wood materials must meet the new construction standards. The material of the wood structure was changed to include new hardwood species like *Hopea ferrea* Dipterocarpaceae instead of *Dipterocarpus alatus* Roxb. Dipterocarpaceae because the new tile roofing

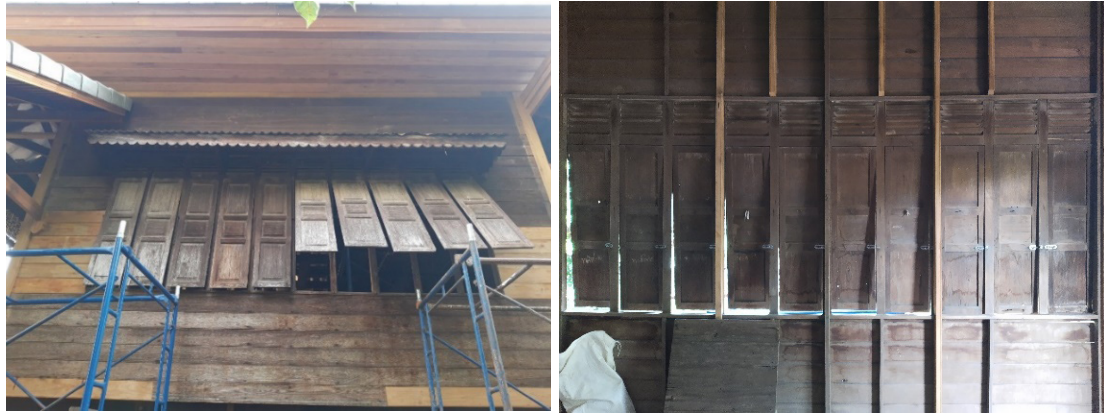
The damaged walls needed to be replaced by a similar quality wood. Only deteriorated wall frames were removed and replaced. As shown in Figure 14, the vertical dark wood frame is the old frame, while the bright teak frame is the new one.

**Figure 14** Replacing the damaged facade with new wood (Credit: North Forest Studio)

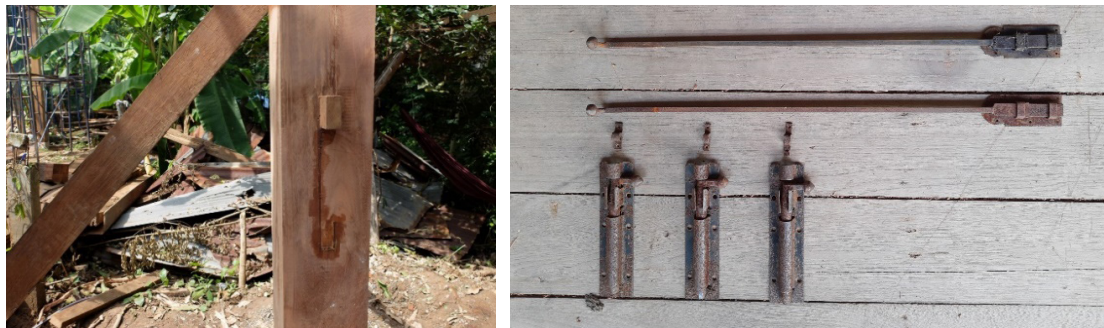
Apart from this, the traditional joint construction, for instance, the Dueai-khen joints, were added in the extension area of the main stairs (Figure 15 (left)). This type of joint, which is generally found in Central Thailand, was used based on the architect's experience, after consultation with the owner. The application of the Dueai-khen in this house was another means to preserve local wisdom. This technique might have been introduced by Hainanese craftspeople who developed wood crafting from boat construction. (C. Nuntapanich, personal communication, February 4, 2022). All the usable accessories were preserved (Figure 15 (right)).

**Figure 15** Inventive intervention of joints and the reusable accessories  
(Credit: (left) researcher, (right) North Forest Studio)

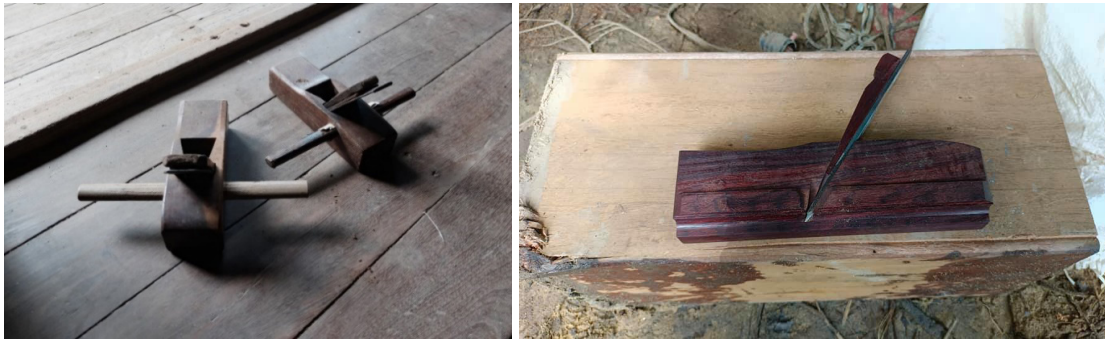
The architect used hand tools instead of machine tools for surface finishing. In the architect's experience, hand tools are better able preserve the nature of the wood. The floor remained as the original version (Figure 16 (left)). The carpenter used both jack planers and smooth planers for refinishing. A jack planer is for a general task and a smooth planer is for finishing the wood surface. A grooving plane also was employed to make grooves on the edge of walls and the wall frames (Figure 16 (right)).

**Figure 16** Traditional tools: (left) a jack planer and (right) a grooving planer  
(Credit: researcher)

Handcraft and traditional tools have both been revitalized. These two things are inseparable since the quality of craft depends on the tools. The architect emphasized the use of hand tools rather than modern power tools because the trace of hand tools is similar to natural wood. Hand tools can also transfer intangible assets such as local skills and knowledge, which is a means to conserve the traditional tools. This intangible element of the project is reflected by the wooden wall frame and the linear lines.
